I-84 Danbury Project Supplemental Needs and Deficiencies Study Technical Memorandum No. 2

**State Project Number
34-349**

December 2020

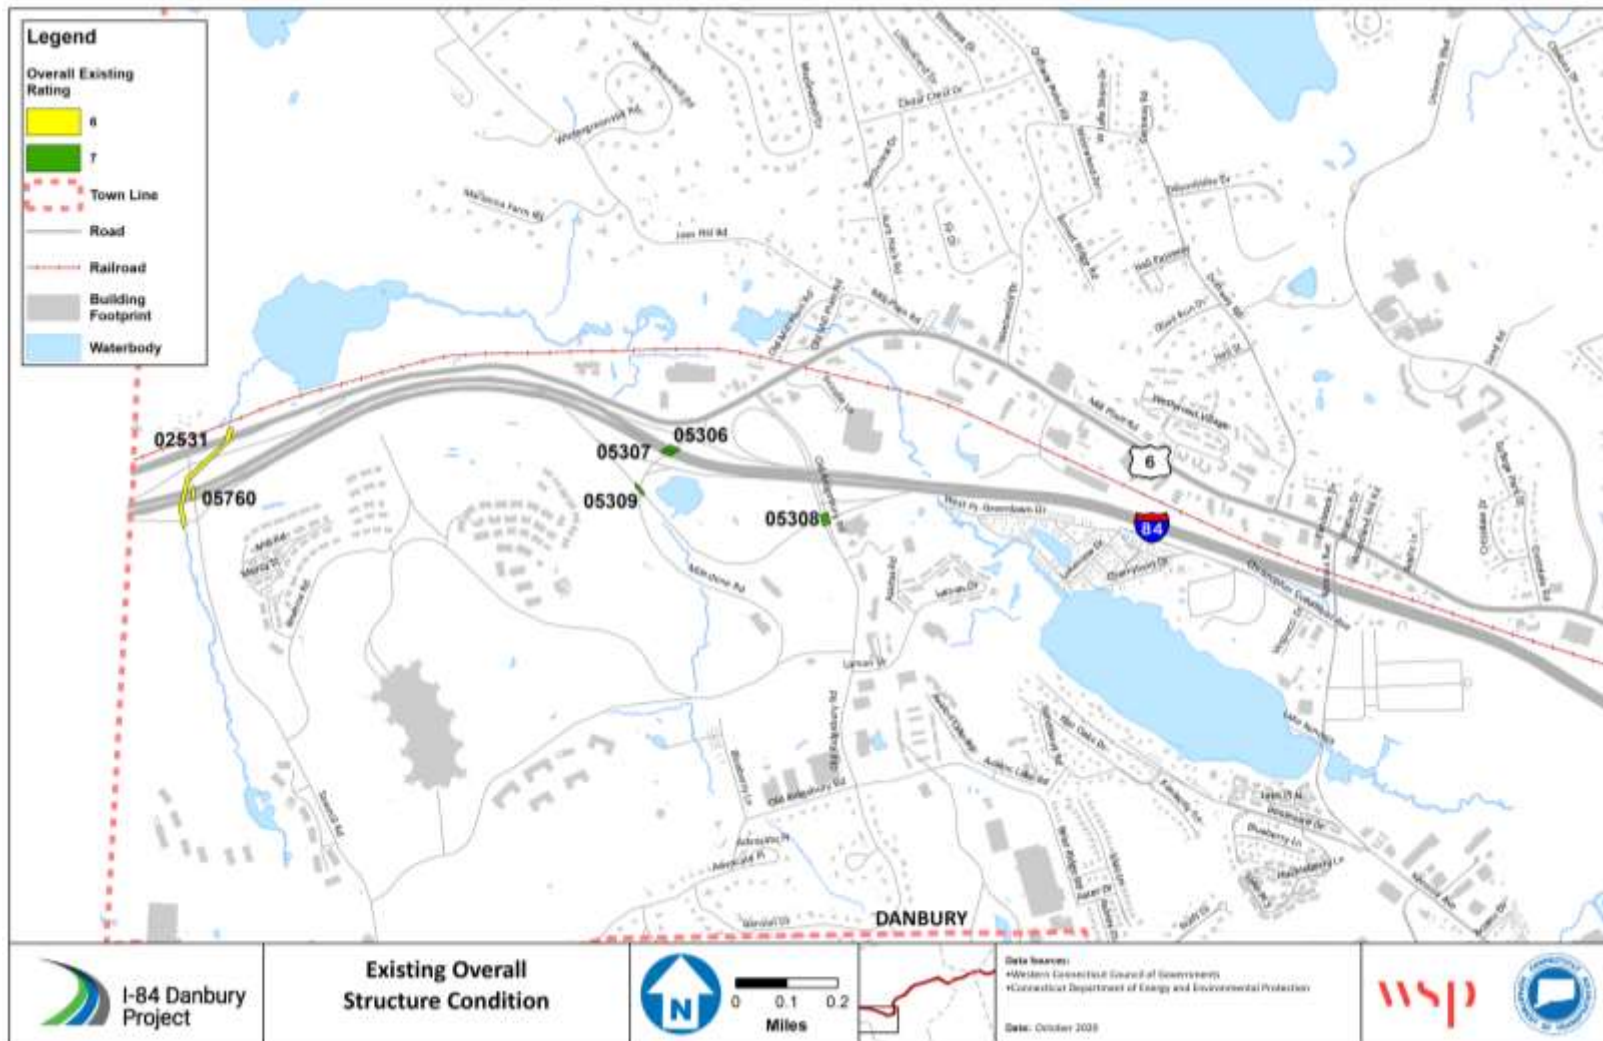
Figure 2-9
Existing Overall Structure Condition

Overall, all of the bridges are in satisfactory condition or better, and none of the bridges have substandard load ratings. Four of the bridges within the extended limits have substandard bridge railing. There is only one structure with fatigue prone details and is well maintained and had no notable deficiencies.

The majority of the bridges within the extended limits have superstructures in good condition with only one structure as satisfactory. The bridge in satisfactory condition, Bridge No. 05760, exhibits areas of peeling paint and moderate rust on webs and bottom flanges of the girders. In addition, the fascia girders have evidence of collision damage. **Table 2-18** outlines the overall condition for deck, superstructure and substructure for the five bridges within the extended limits.

Table 2-19 contains the breakdown of the structural condition of the culvert within the extended limits. The culvert is considered satisfactory. It has locations of active leakage and efflorescence staining between adjacent units. There is isolated spalling with exposed rebar and hairline cracking.

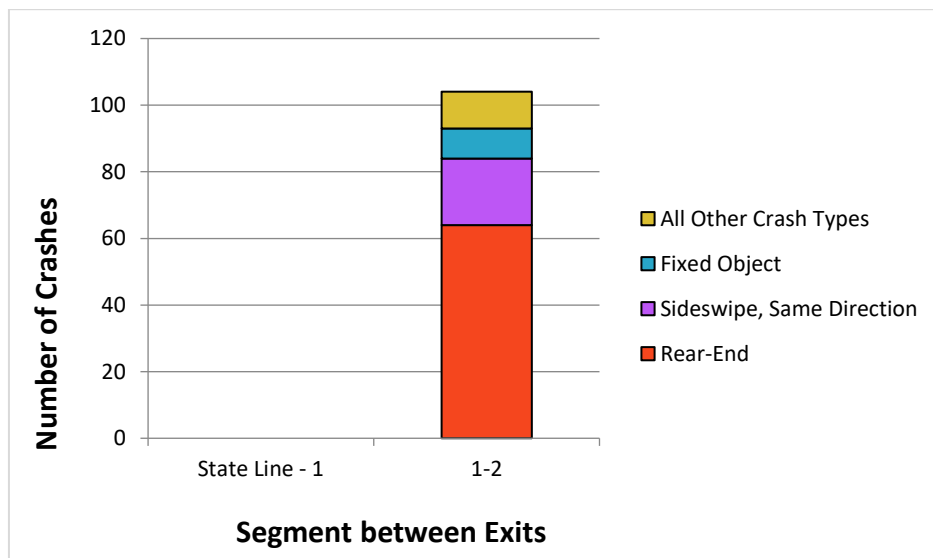
Figure 2-10
I-84 Eastbound – Mainline Crash Types

As shown in **Figure 2-10**, the predominant crash type was rear-end crashes, followed by sideswipes and fixed objects. Of the 104 crashes reported, 64 (approximately 62 percent) were rear-end, 20 (approximately 19 percent) were sideswipes, 9 (approximately 9 percent) were fixed object and the remaining 11 (approximately 11 percent) were other types. Most of the rear-end crashes were reported due to vehicles improper passing or failing to keep in proper lane.

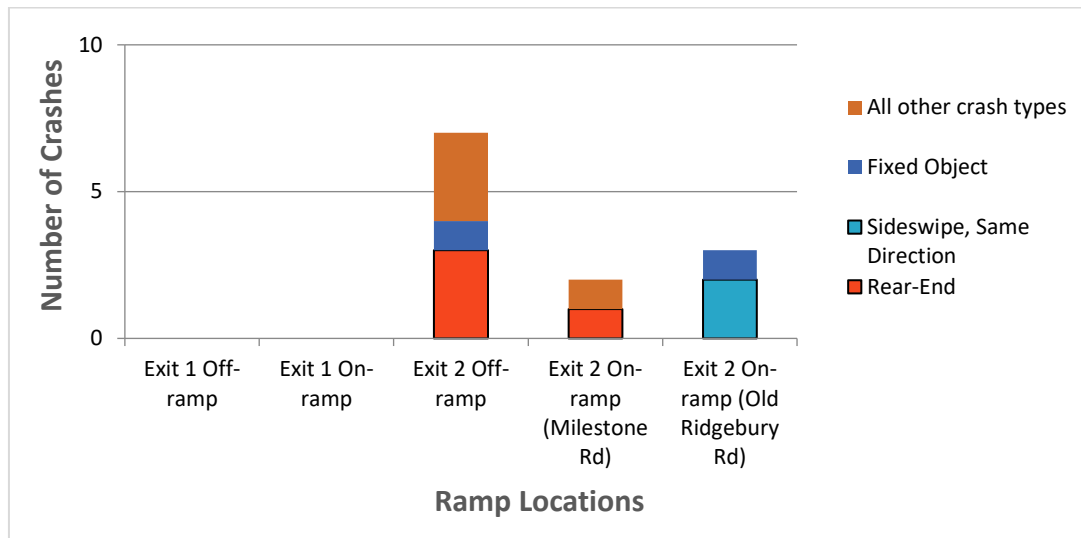
Figure 2-11
I-84 Eastbound – Ramp Crash Types

As shown on **Figure 2-11**, rear-end crashes were predominant at Interchange 2 off-ramp due to vehicles were operated in reckless aggressive manner or drivers were inattentive manner following too closely. In addition, sideswipe, same direction crashes were predominant at Interchange 2 on-ramp (Old Ridgebury Road).

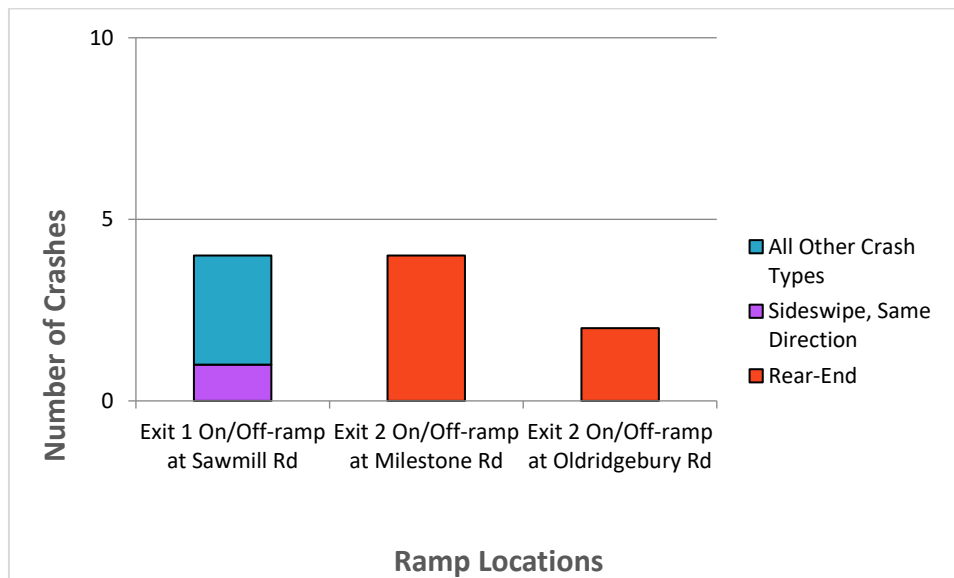
Figure 2-12
I-84 Eastbound – Ramp Crash Types

As shown on **Figure 2-12**, rear-end crashes were predominant at Interchange 2 on/off-ramp at Milestone Road due to vehicles failed to grant right-of-way.

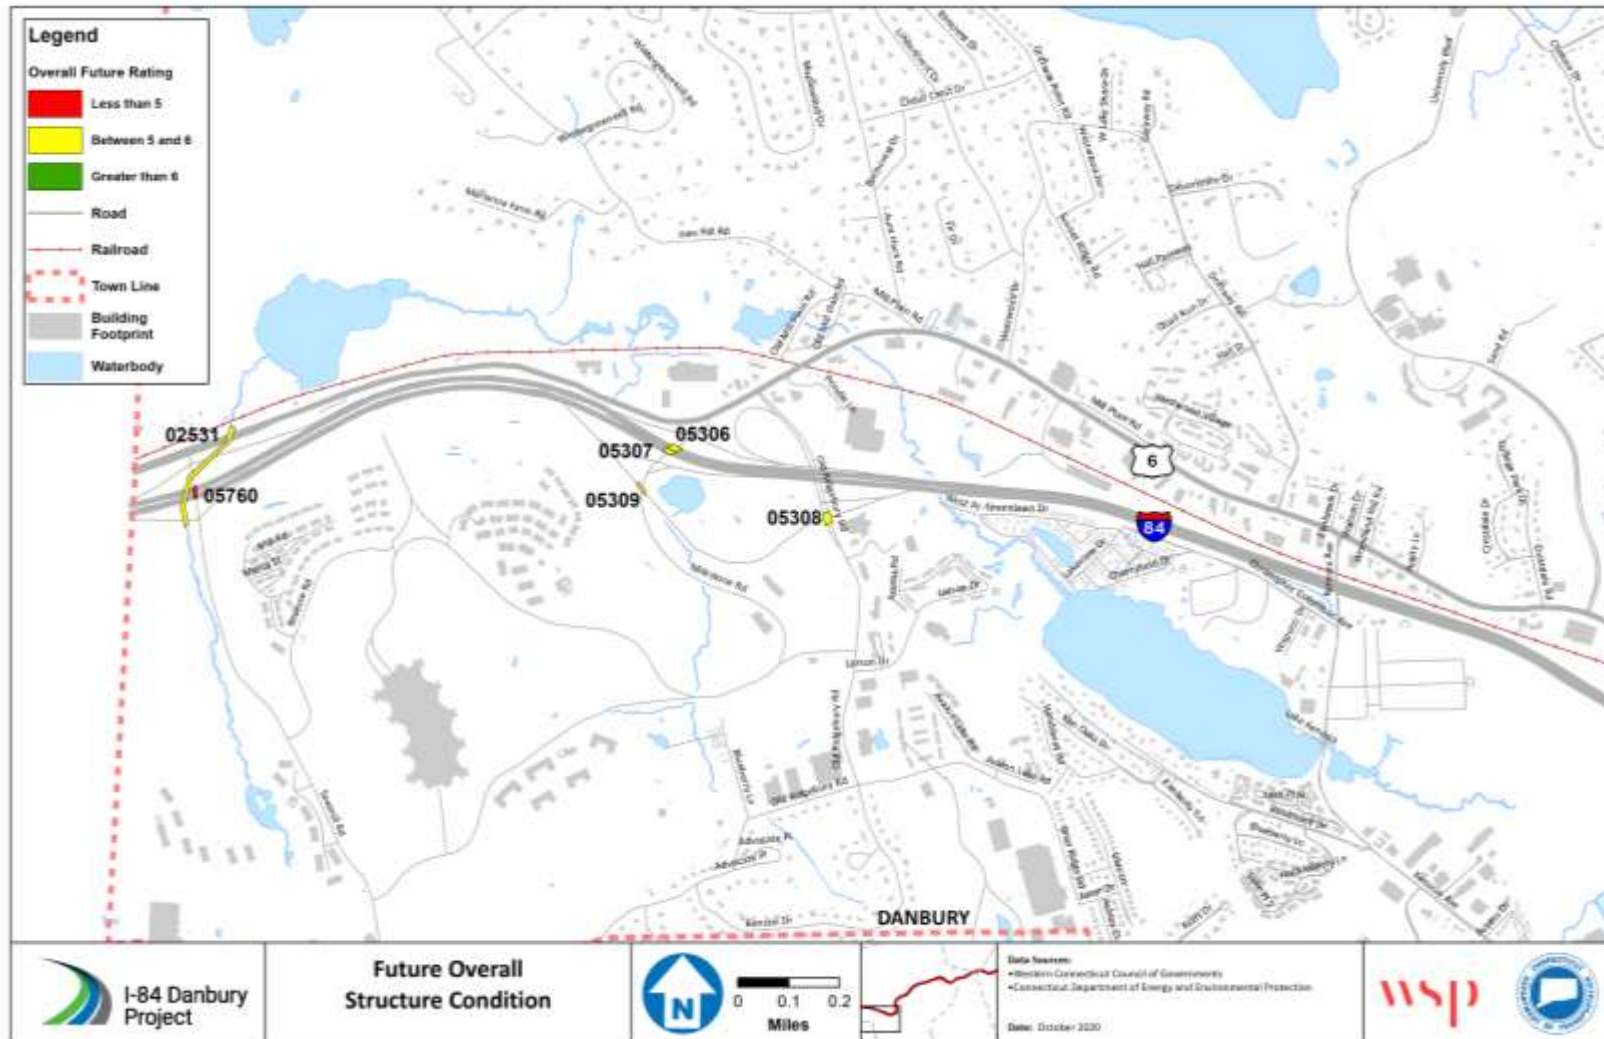
Figure 3-5
Future Overall Structural Condition

Figure 3-5 provides a graphical representation of the extended project limits based on the future overall structure condition, which is taken as the minimum rating of deck, superstructure, substructure, and culvert future rating.
