I-84 Danbury Project Needs and Deficiencies Report Technical Memorandum No. 1

I-84 Danbury Project

State Project Number 34-349

October 2018

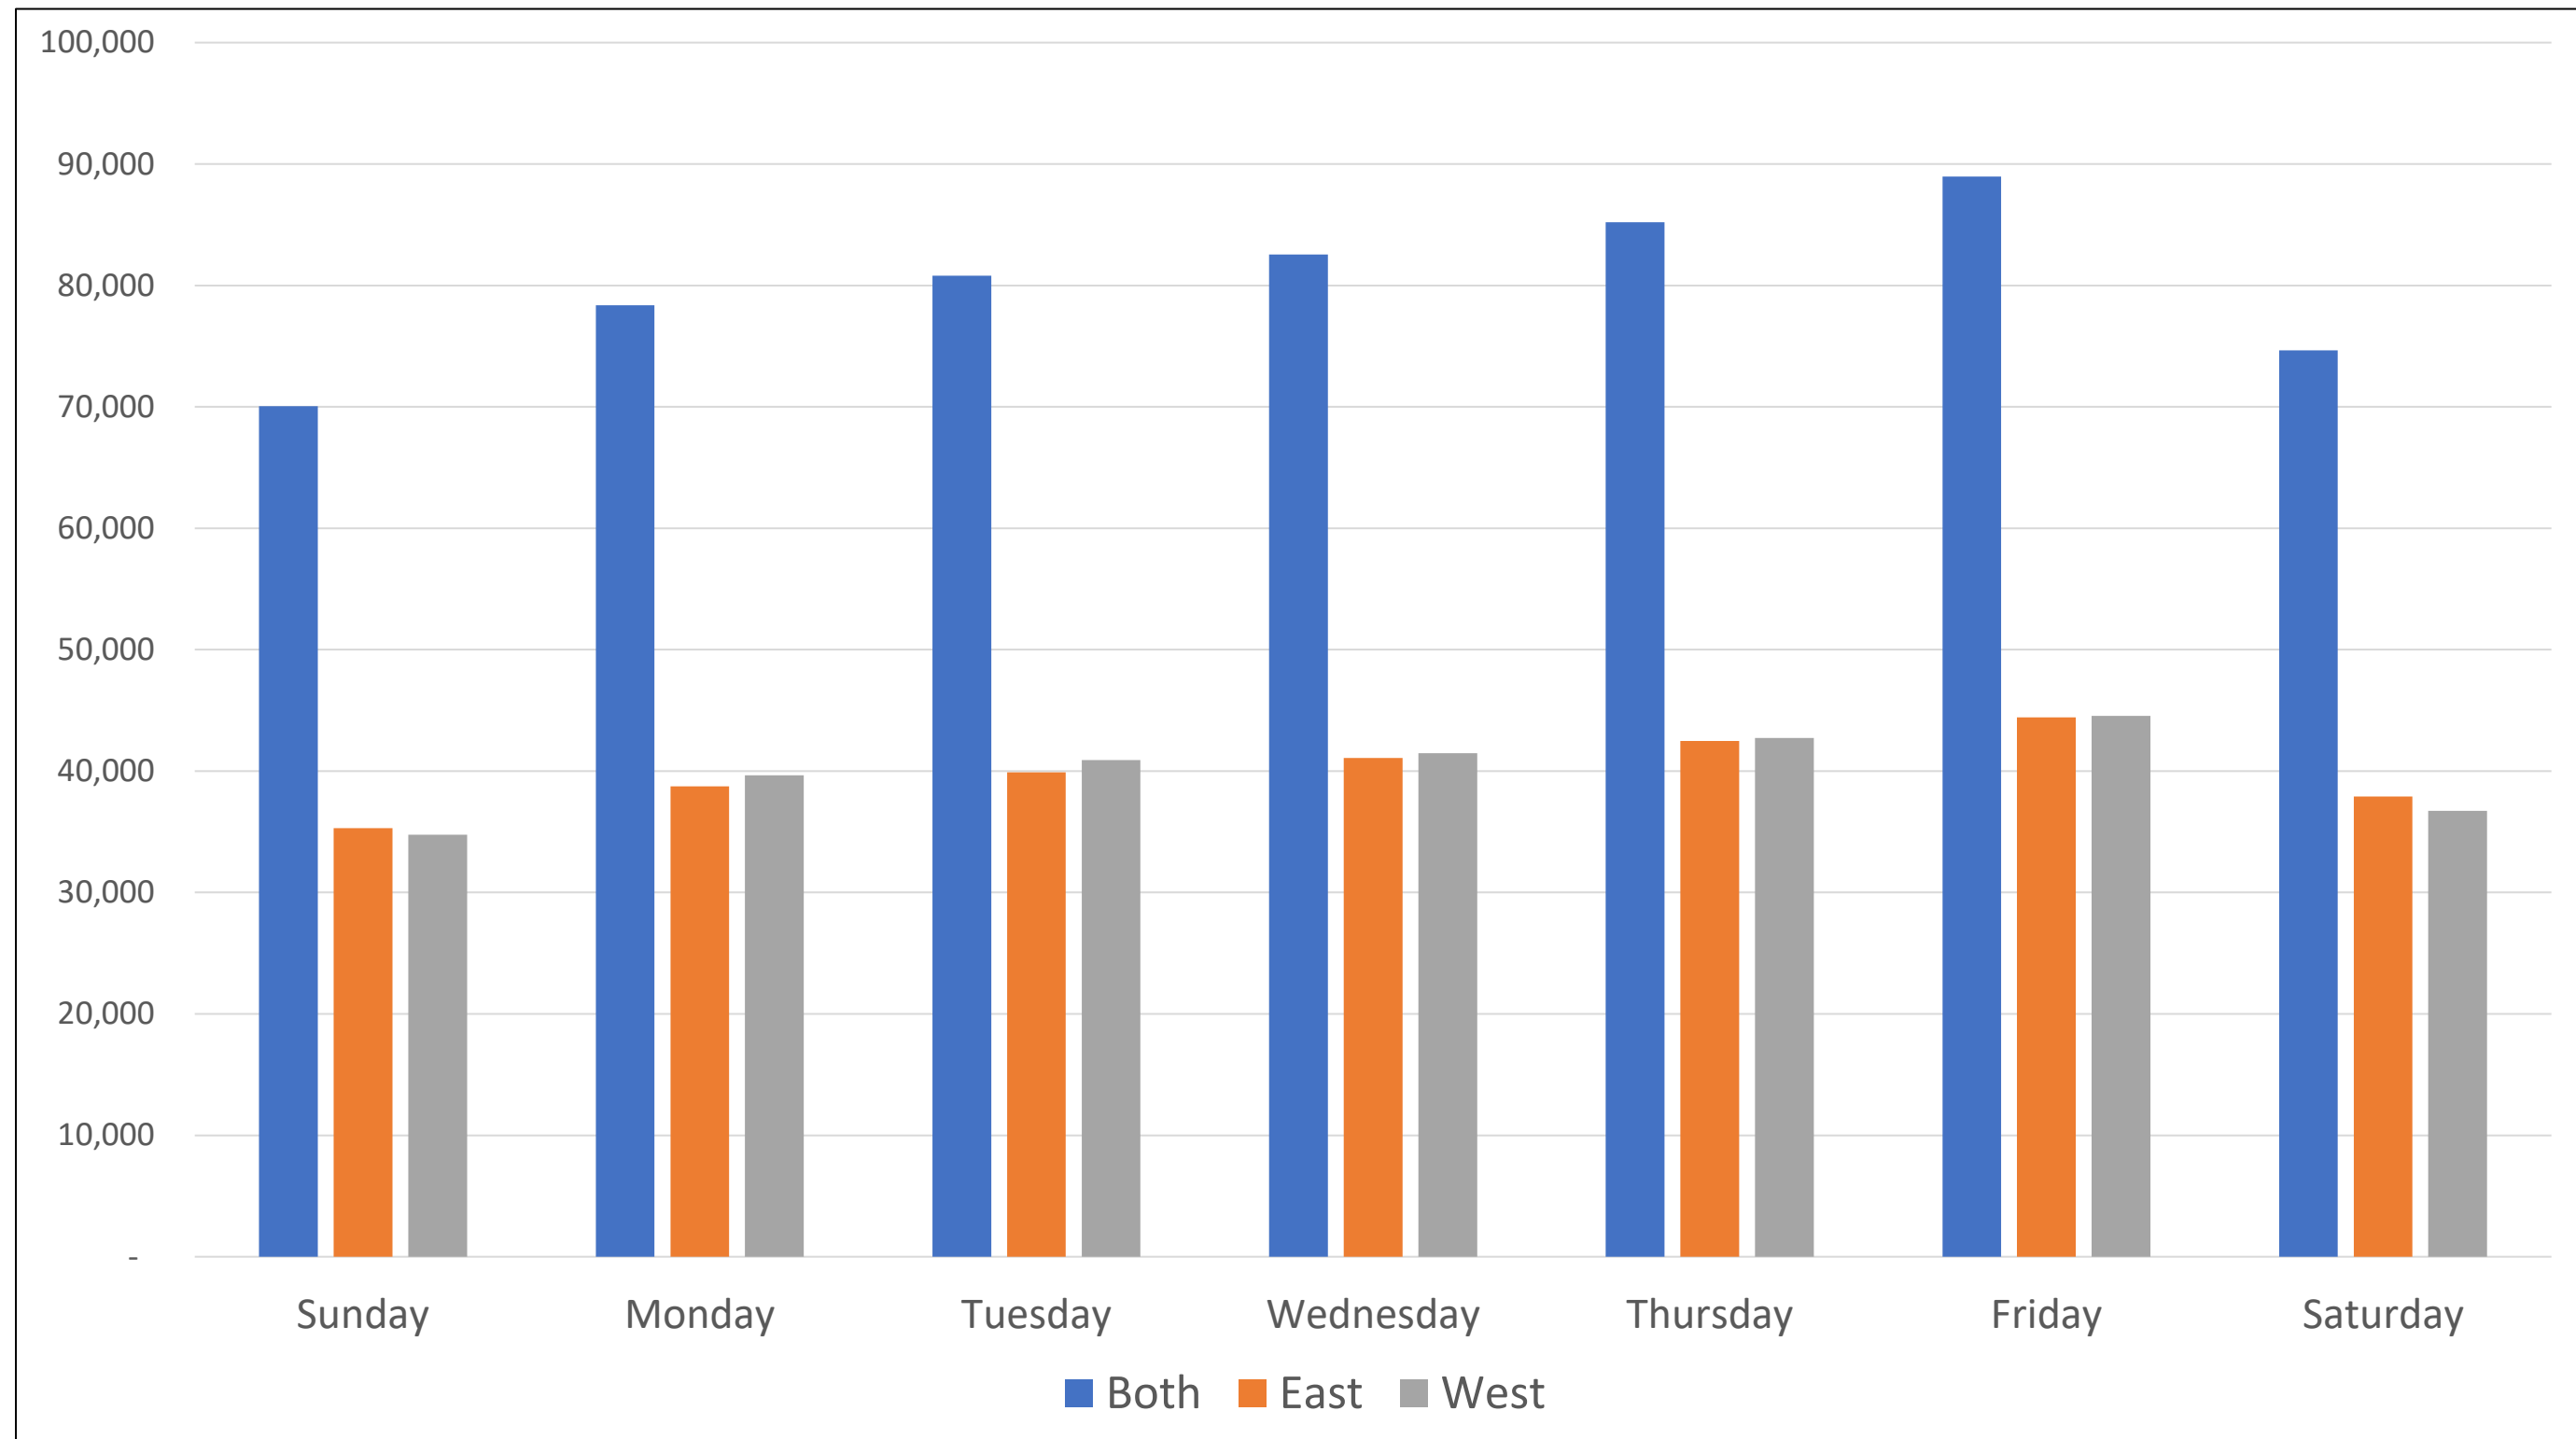
Figure 2-1 Weekday Variation in Daily Traffic Volumes

The above traffic counts were conducted for a 12-hour period between 6 A.M. and 6 P.M. and extrapolated to develop a daily count profile for the corridor. **Table 2-1** shows the existing (2016) weekday daily, A.M., and P.M. peak hour volumes at three (3) locations in the study corridor.

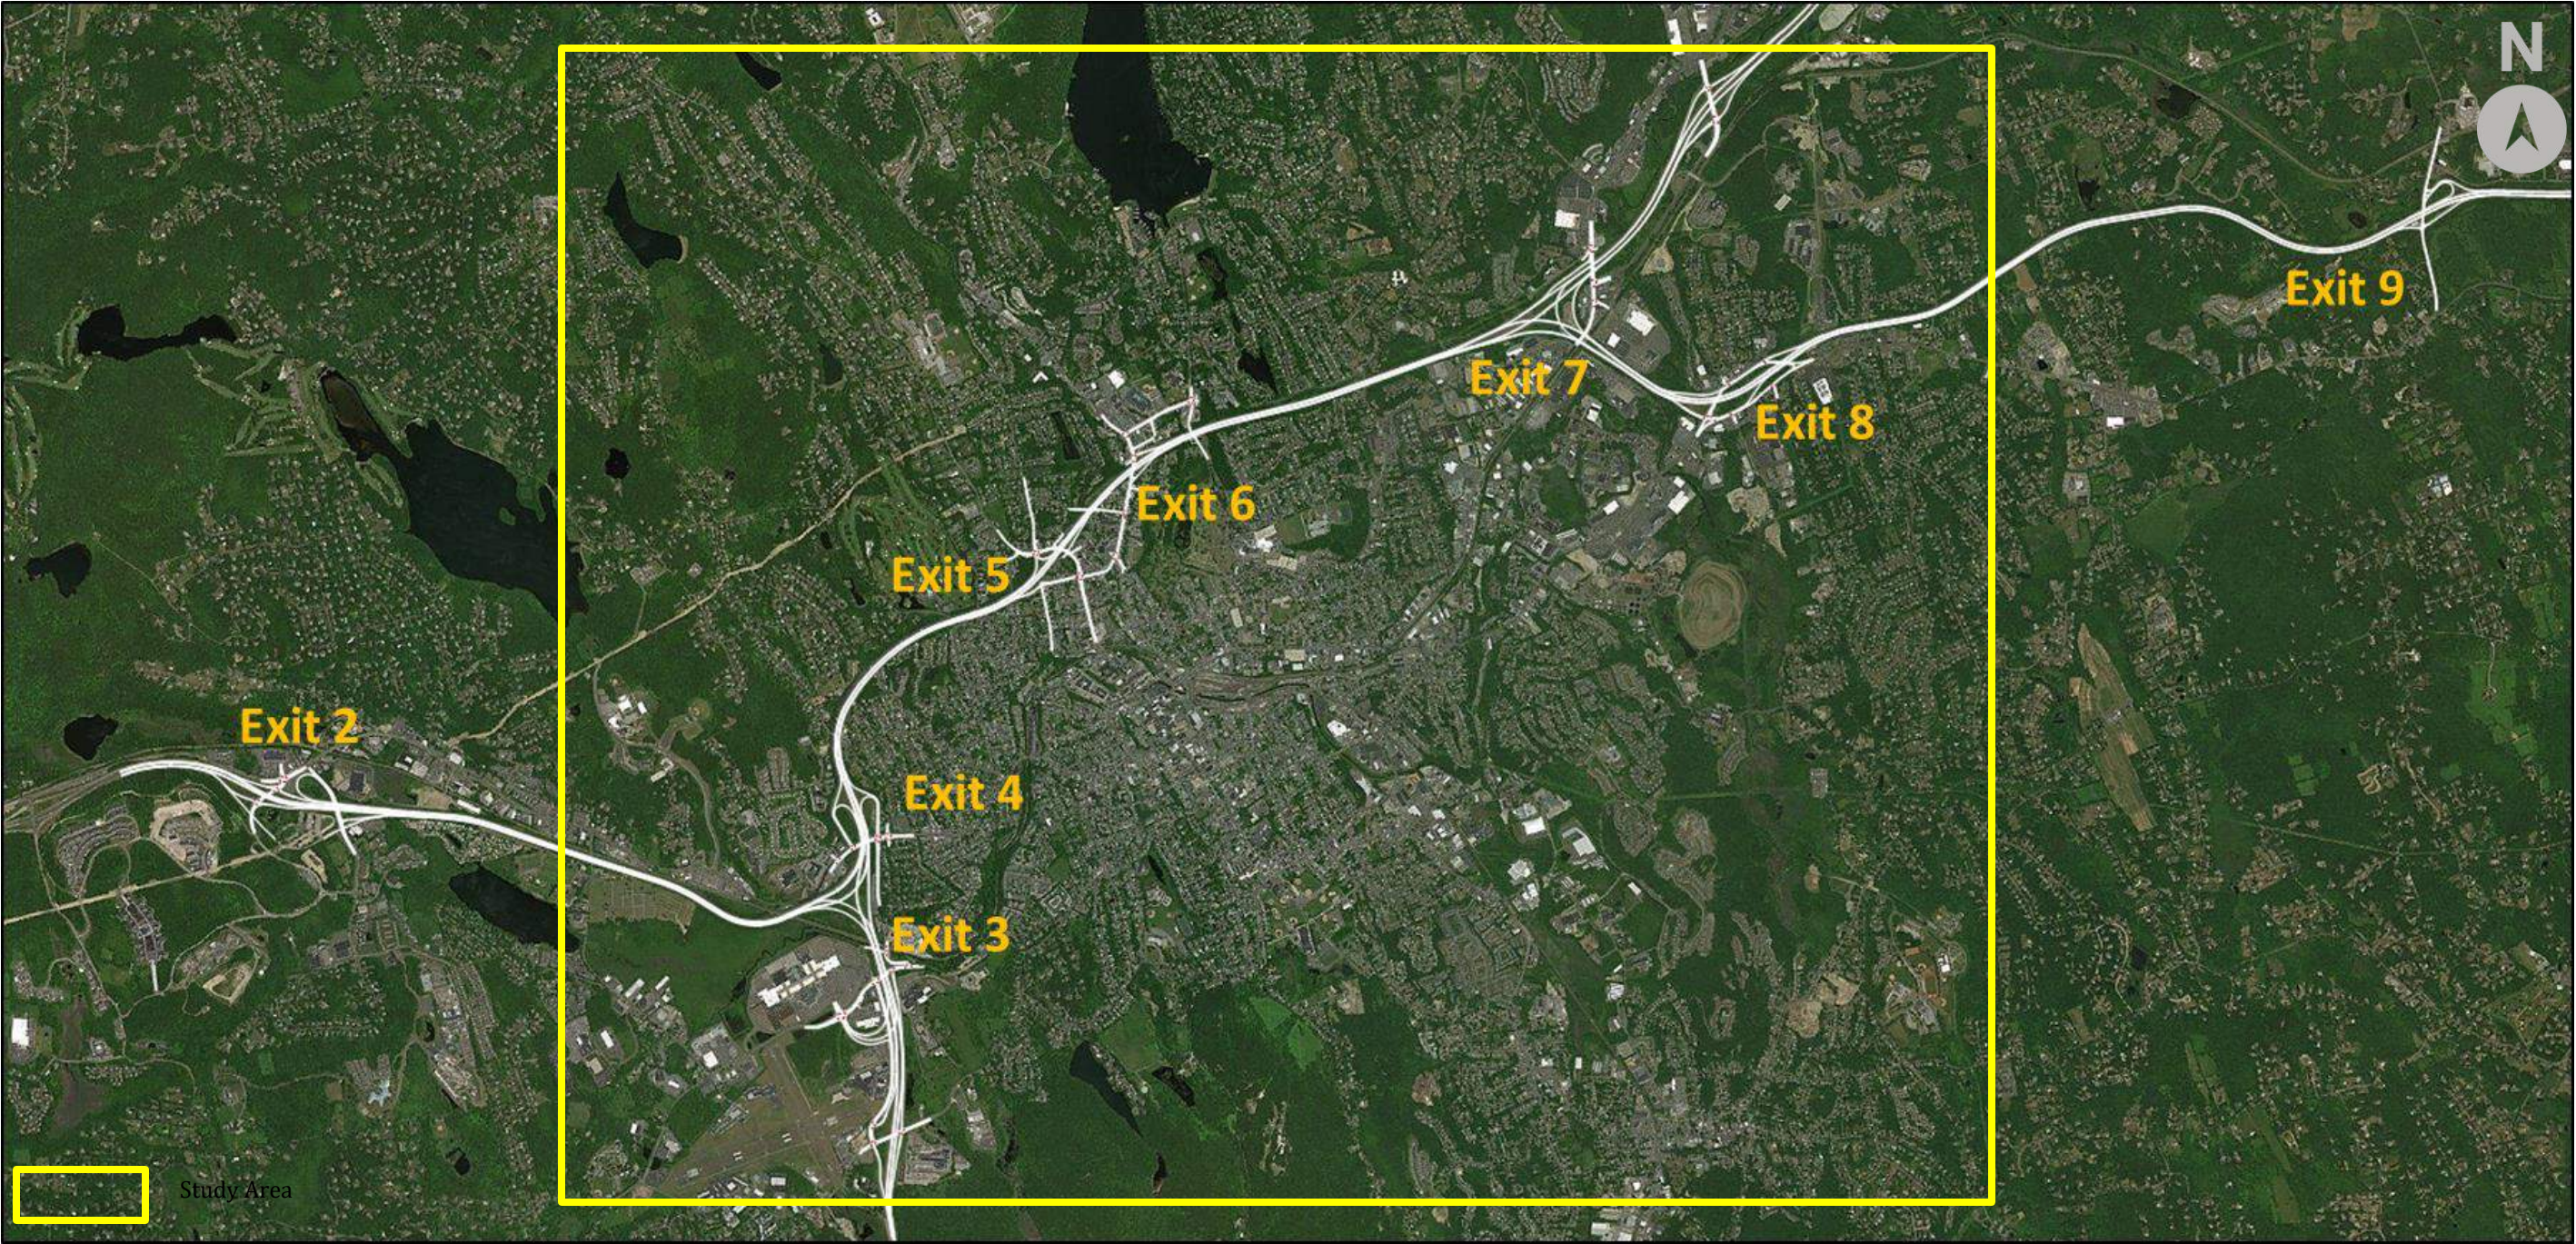
Figure 2-11 VISSIM Model Area

VISSIM models were developed for the weekday A.M. and P.M. peak hour periods. The weekday A.M. model was developed for the 6:00-9:00 A.M. period and the weekday P.M. model was developed for the 3:00-6:00 P.M. period. The model was developed for three-hour periods to accurately represent build-up and dissipation of congestion on I-84. **Figure 2-11** shows the limits of the study area included in the VISSIM model. As described in the Traffic Operations Technical Appendix, the model met the traffic volume and the travel time criteria established by the FHWA to satisfy calibration requirements.

Weekday P.M. Peak Period - As shown in Figure 2-11, during the P.M. peak period, in the eastbound direction, approximately 26 percent of the traffic entering I-84 at Exit 3 is going through on Route 7, approximately 19 percent of the traffic continues on I-84 to the east, and the remaining 55 percent of the traffic is oriented towards local streets. In the westbound direction, approximately 32 percent of the traffic entering I-84 from Route 7 is going through on Route 7, approximately 34 percent of the traffic continues on I-84 to the west, and the remaining 34 percent of the traffic is oriented towards local streets.

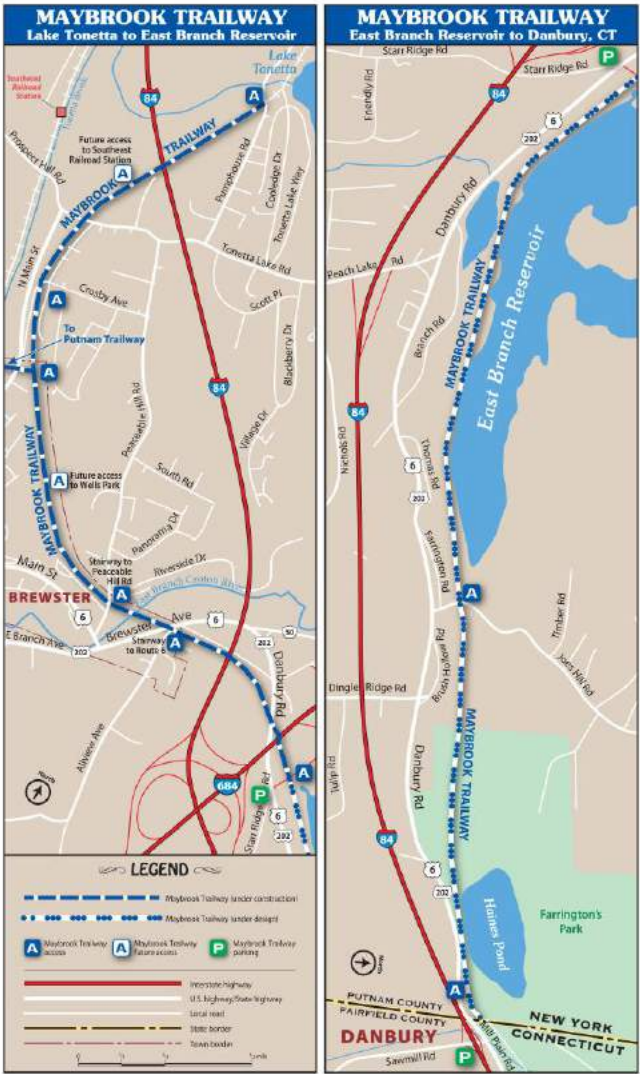
Figure 2-62 - Maybrook Trailway in New York State

As discussed in Section 2.7.4.3, west of the city of Danbury, the New York State Department of Transportation is working to convert a portion of freight rail right-of-way associated with the Maybrook Line. The so-called Maybrook Trailway, shown in **Figure 2-62**, will connect the western border of Danbury in the adjacent Putnam County, to Brewster, New York. Currently, the Maybrook Trailway runs from Lake Tonetta in Brewster, New York east to the general vicinity of the I-84 – I-684 interchange.
