# I-84 Danbury Project Needs and Deficiencies Assessment

I-84 Danbury PEL Study

# I-84 Danbury Project Needs and Deficiencies Report Technical Memorandum No. 1

**State Project Number 34-349**

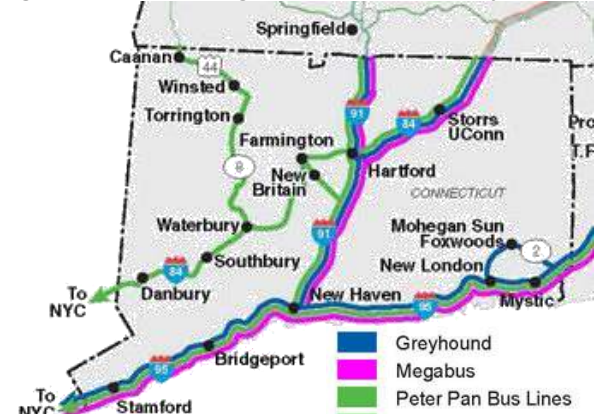
Figure 2-75 – Interregional Bus Service Map

Peter Pan operates an interregional bus route from Hartford to New York with stops in Danbury, Southbury and Woodbury. In each direction, the company provides seven daily trips Monday-Thursday and Saturday and eight trips on Fridays and Sundays. Greyhound and Megabus also operate interregional busses in the area, but those busses do not run along the I-84 corridor. Instead those companies travel along the I-91 and I-95 corridors and service cities between Hartford and New York City. These bus services are shown in **Figure 2-75** below.
